Earthquakes of 1999 - Issues for Catastrophe Risk Management

Charles Scawthorn¹
EQE International

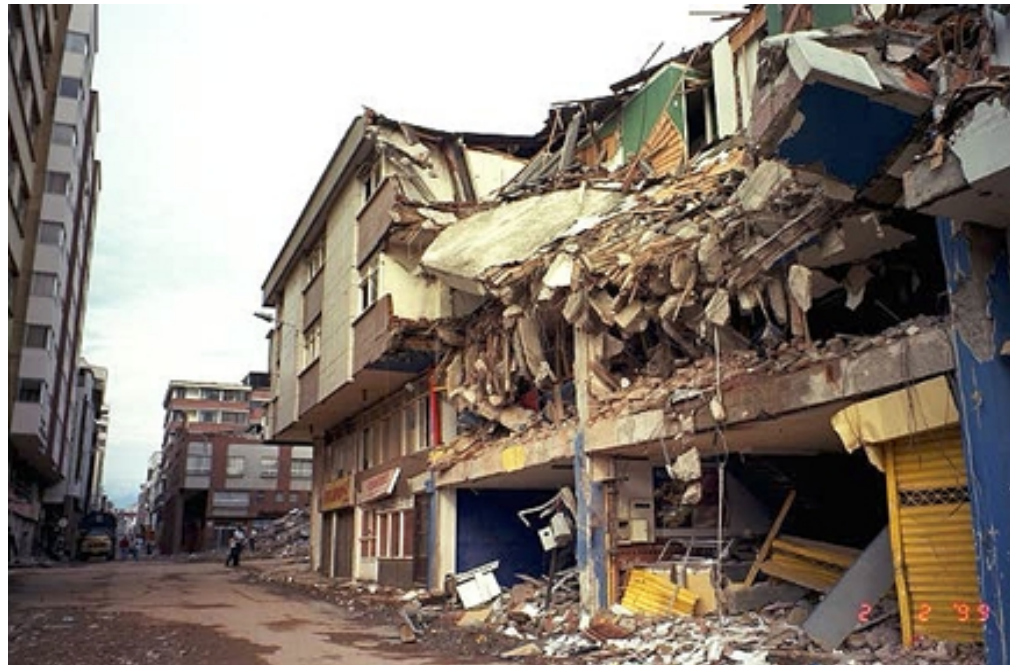
Figure 1 – Armenia Colombia earthquake – accelerations and example of damage.

This event occurred at 13:19 local time within a system of intraplate faults parallel to the Andes mountains trending northeast. The system is characterized by strike-slip faults, and can generate strong shallow earthquakes (Asfura and Flores, 1999). Most of the structural damage was concentrated in areas of deep layers of volcanic ash or man-made non-engineered fills, with neighborhood estimates of damage ranging to 95%. Most of the damage was to one- and two-story houses and apartment buildings of four to five stories, Figure 1. Approximately 1,200 persons were killed.

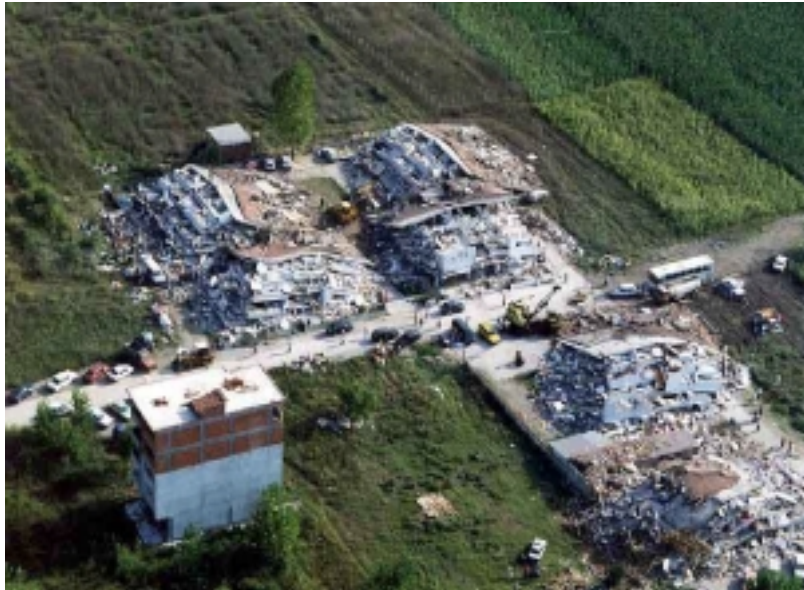
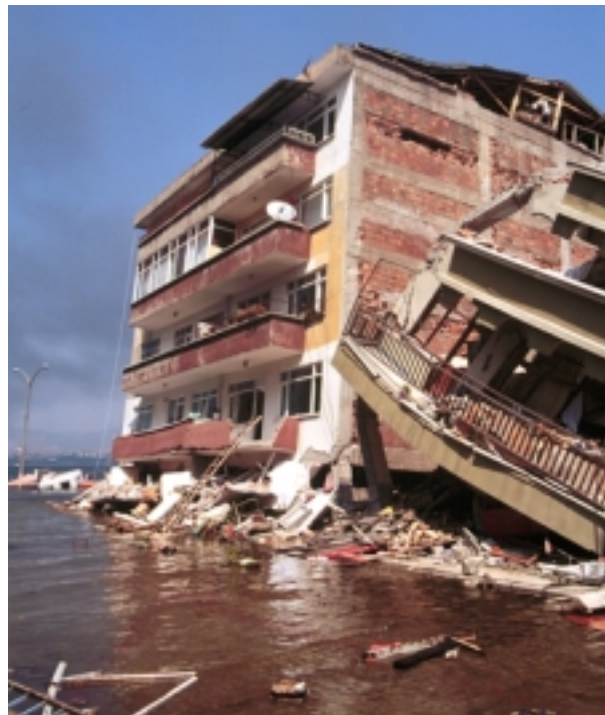
Figure 3 – examples of damage, Marmara Turkey earthquake.

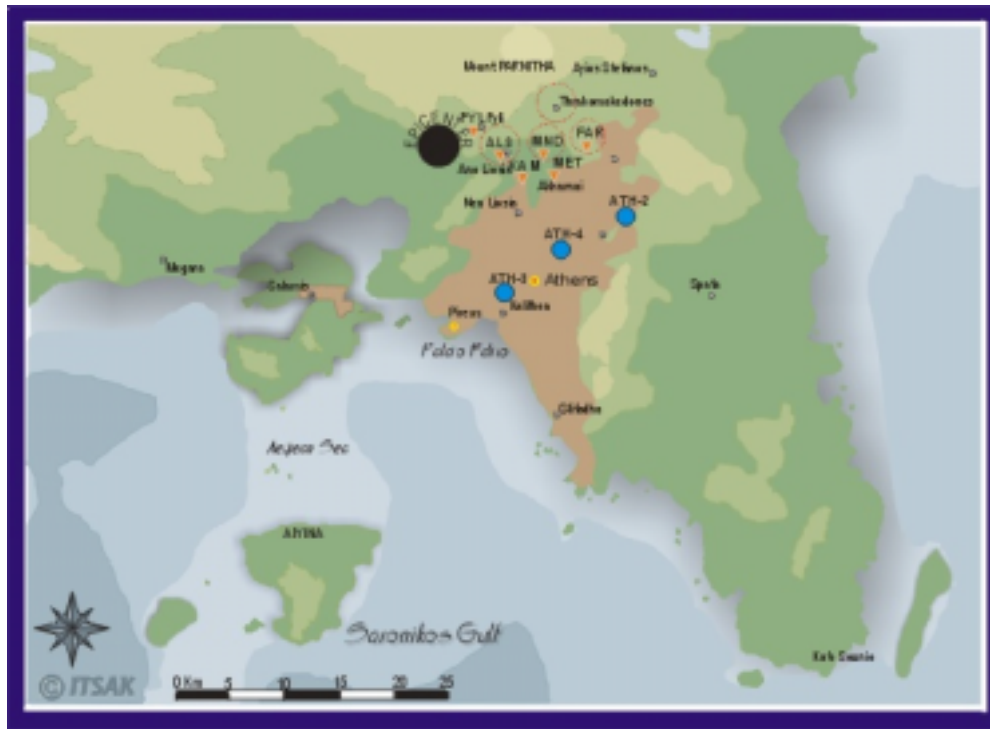
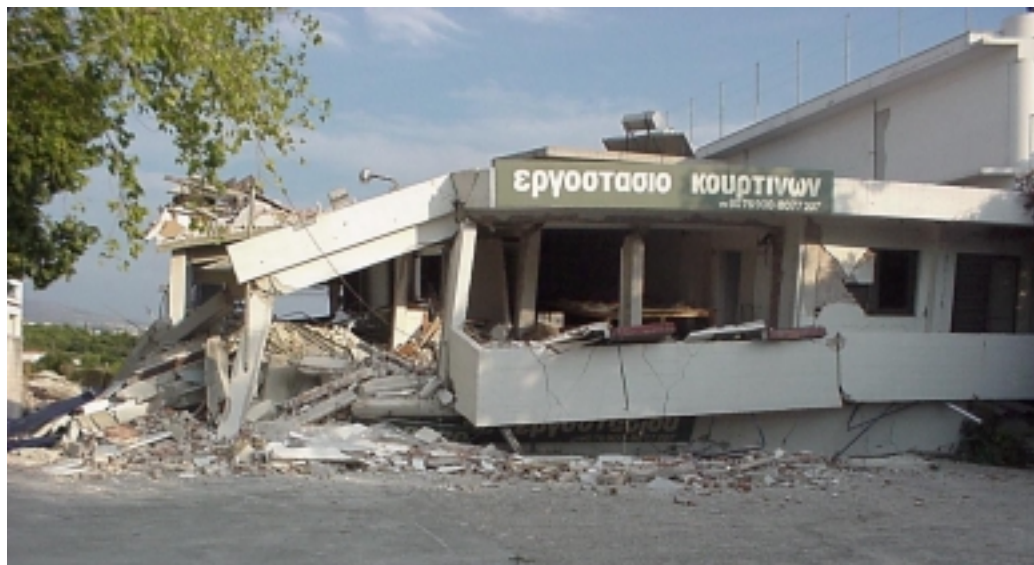
Figure 3 Location of Athens Earthquake , and typical damage
(<http://www.itsak.gr/report.html>)

This event occurred at 15:00 local time, affecting primarily the Northern Athens District of Menidi (also called Aharnes). It was felt strongly in Thrace-Macedoni and Metamorphosi (Figure 3). Confirmed deaths are 124, with approximately 100,000 homeless. Total costs for the event are estimated at \$600 Million, and unemployment is expected to rise to 30,000 in the affected areas.

The majority of the residential housing in this area of Athens consists of 3-to 5-story reinforced concrete apartments. The ground floor is usually left open to act as a garage. This particular area of Athens has seen a large amount of (initially) unauthorized development and construction of houses by their owners. The level of engineering design and control that has been exercised is highly variable. There have been a number of collapses, which have resulted in loss of one or two stories, and at least four complete collapses. In addition, there were many structures, which were badly damaged. This was the result of clear breeches in good design practice coupled with poor detailing especially of steel confinement. The failures observed were as a result of the following:

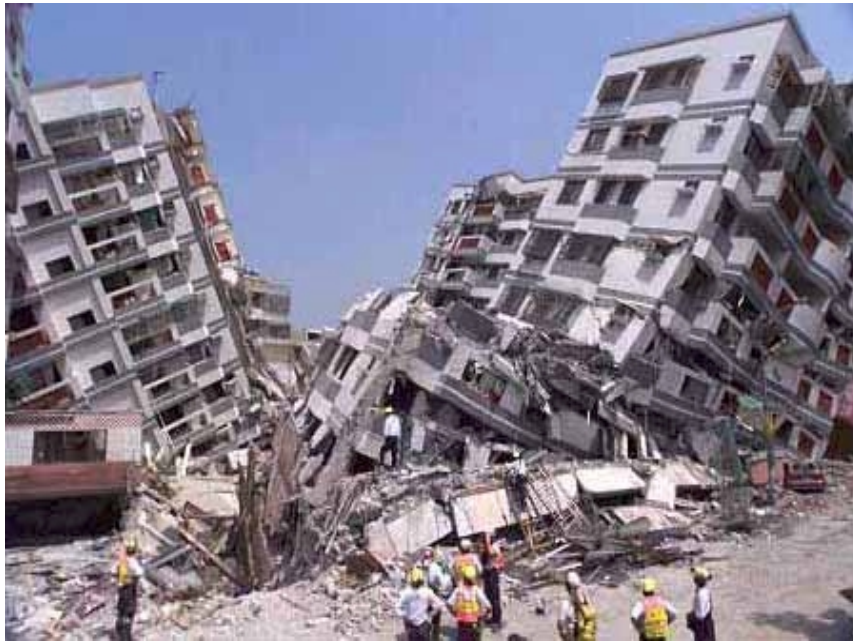
Figure 4 – Strong Motion instrument sites, isoseismal intensity patterns, and example of building damage, Taiwan earthquake.

Well over 10,000 buildings collapsed or were severely damaged. The collapsed buildings were predominately of reinforced concrete framing, with infill masonry walls or reinforced concrete walls, and ranged from older, smaller buildings to modern high-rises. At distances more than about 5 km from the fault line, it was repeatedly observed that the older buildings performed well, but many of the modern structures over six stories tall performed poorly. This can be attributed to faulty design and construction, and improper enforcement of seismic design provisions in the building code - even though the building code used in Taiwan is comparable to those used in Japan and in California.
